REFURBISHMENT OF THE  
KURDISTAN REGIONAL GOVERNMENT  
MINISTRY OF INTERIOR COMPLEX  
UNDER THE COMMANDER'S EMERGENCY RESPONSE PROGRAM  
ERBIL, IRAQ

**SIGIR PA-08-119**  
**APRIL 17, 2008**

SUBJECT: Report on Project Assessment of the Refurbishment of the Kurdistan  
Regional Government's Ministry of Interior Complex, Erbil, Iraq  
(Report Number SIGIR PA-08-119)

## **Refurbishment of the Kurdistan Regional Government Ministry of Interior Complex Erbil, Iraq**

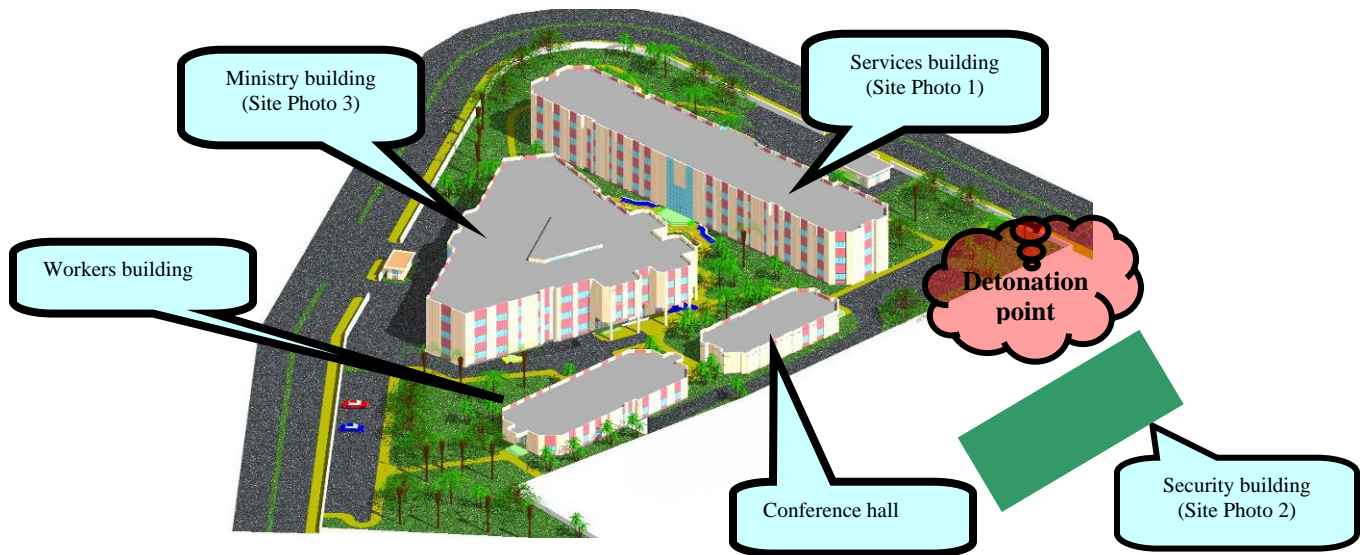
**Figure 1: Architectural layout of the MOI complex**

located across the street from the complex. Because it was early morning, most MOI employees had not arrived and loss of life was limited to the guards and passengers in passing vehicles. Figure 1 illustrates the layout and detonation point. Site Photos 1 through 3 show examples of damage to the three major buildings.
